19th CENTURY HOUSES OF OLD CAIRO QUARTERS

Salah Zaky Said

المجلس الأعلى للثقافة

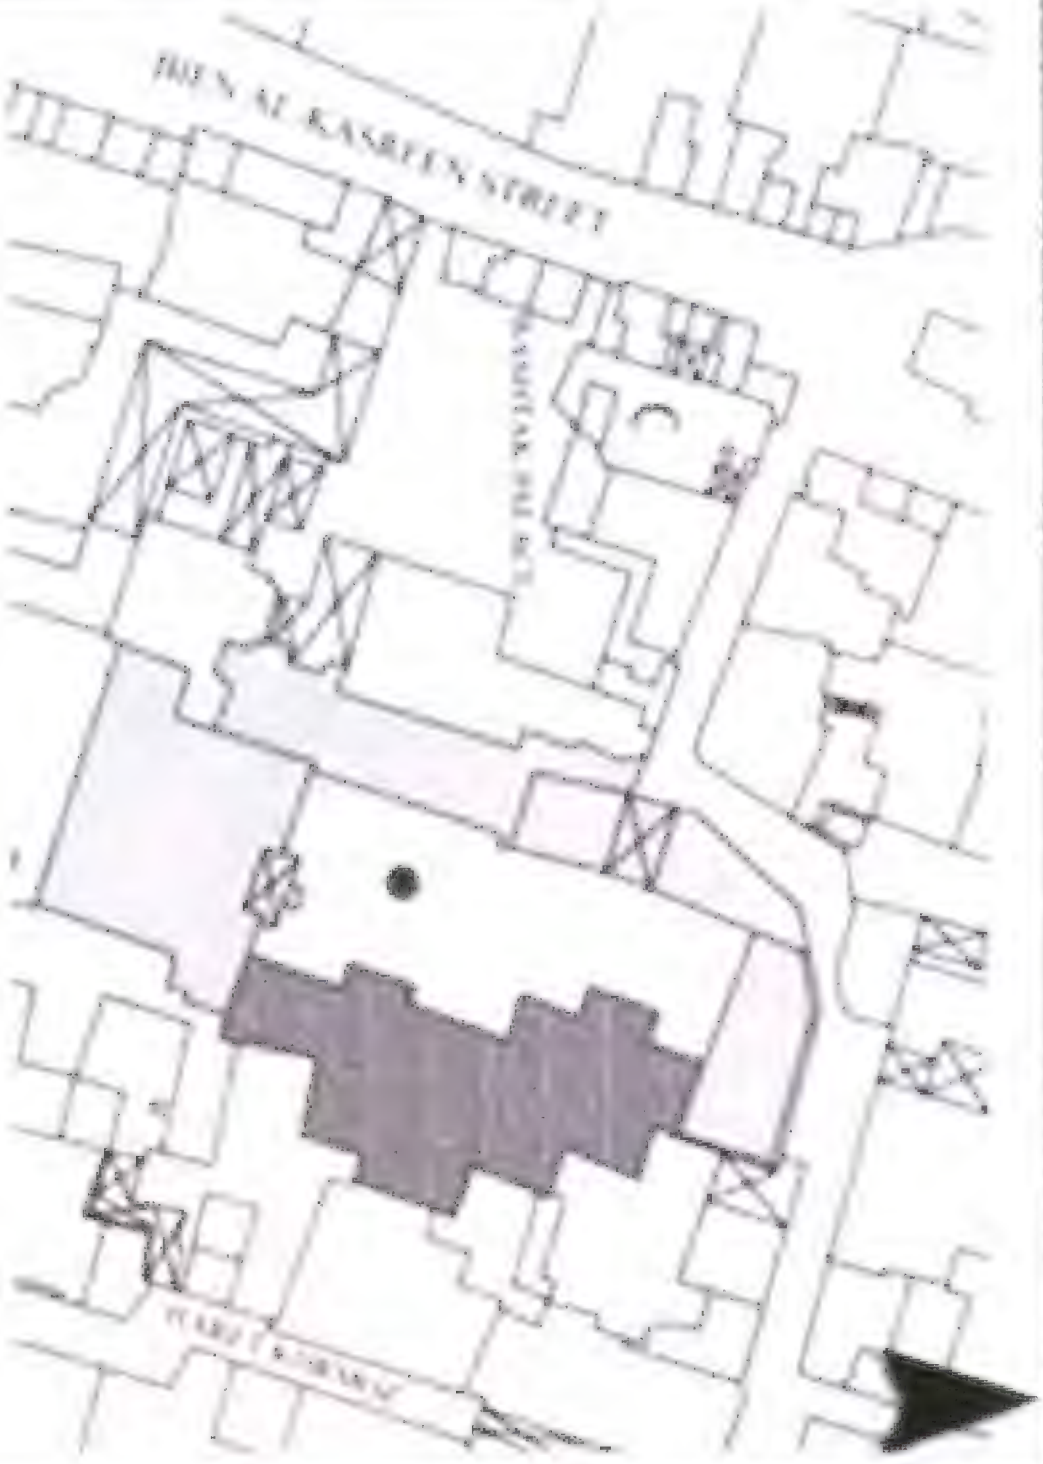
<p>First Floor Plan</p>

<p>Foundation date: 19th century.</p> <p>Brief description: Two houses around a court. The house was built for extended families and overlooks a large court . Two floors, each floor has two large apartments. The house has a wooden Turkish style engraved panel over al-maga ad.</p> <p>Apartment area: 150m².</p>

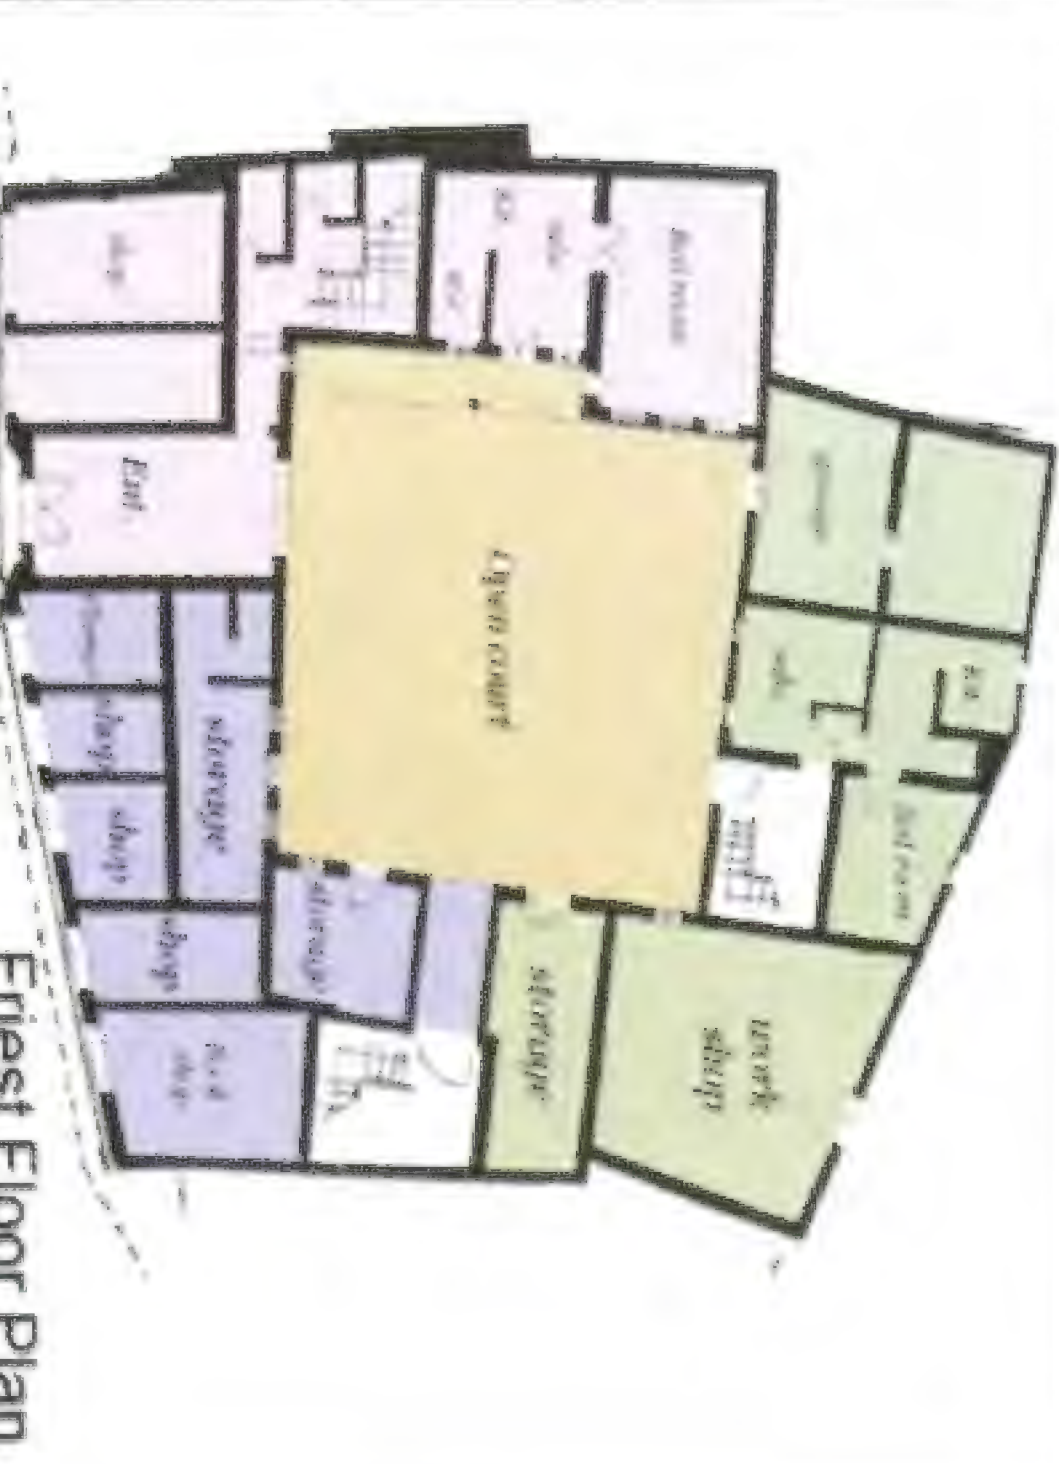
<p>First Floor Plan</p>

<p>Foundation date: 19th century.</p> <p>Brief description: The house was built for a famous singer called Sakna. Three blocks of houses around a large court (12 x 12m). This design is usually creates for extended family. Each house has a separate staircase. Each block has the typical design of a sala overlook-ing the court with rooms around it.</p> <p>Apartment area: 120-150 m².</p>

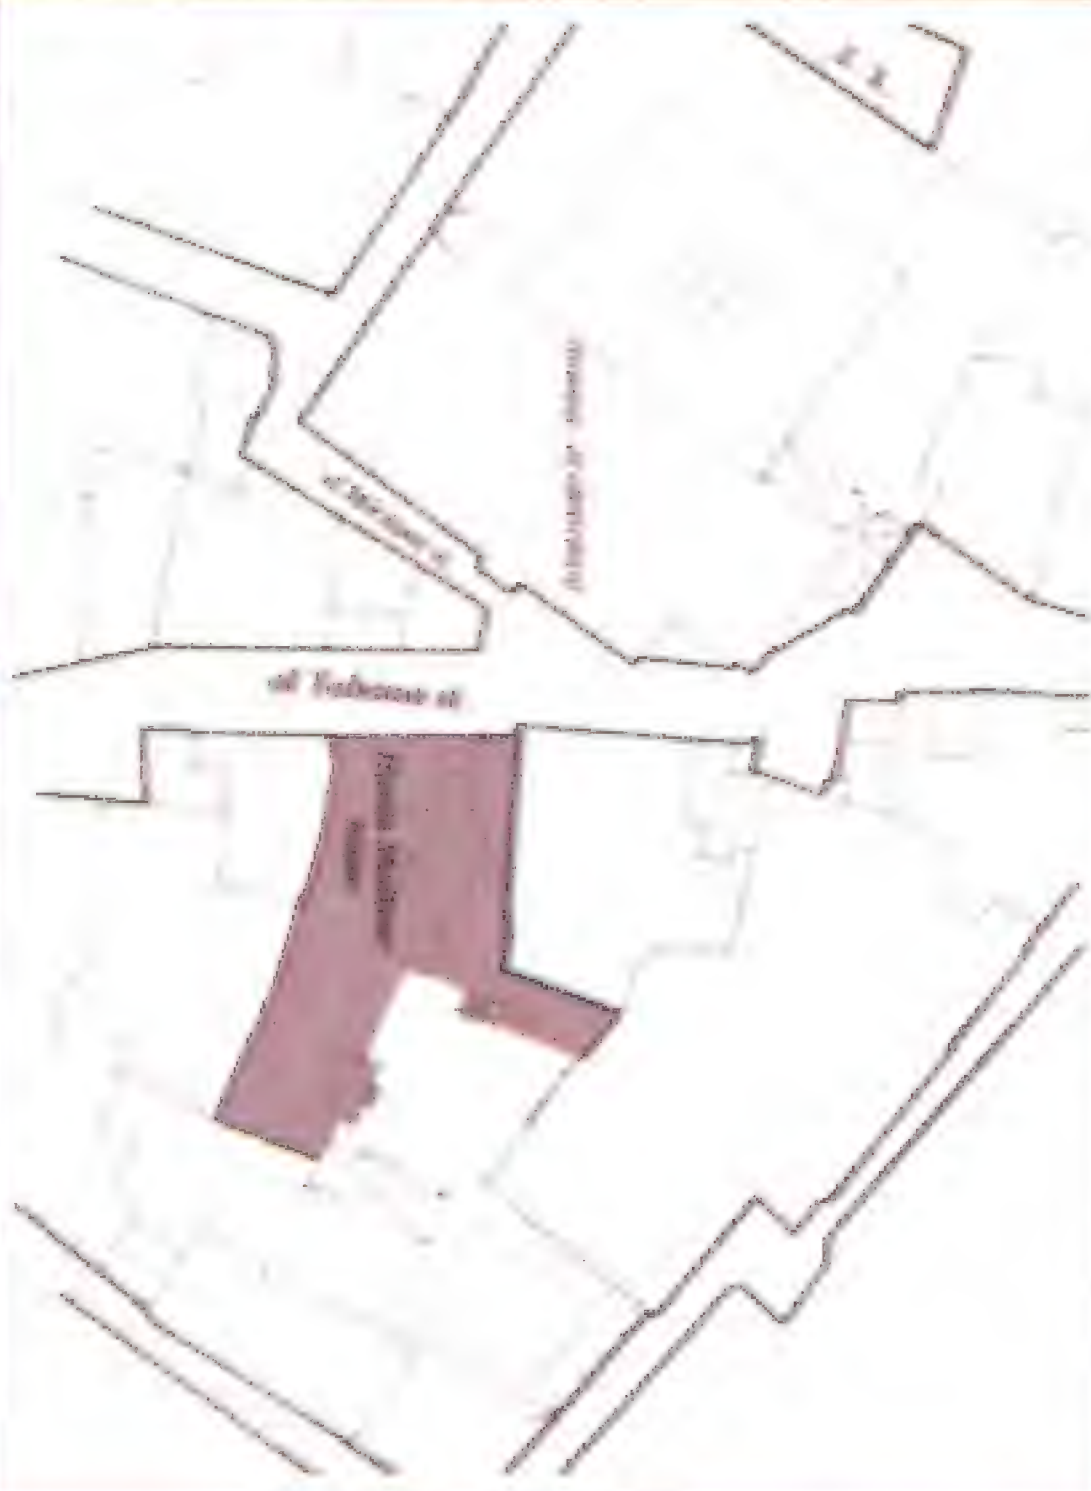
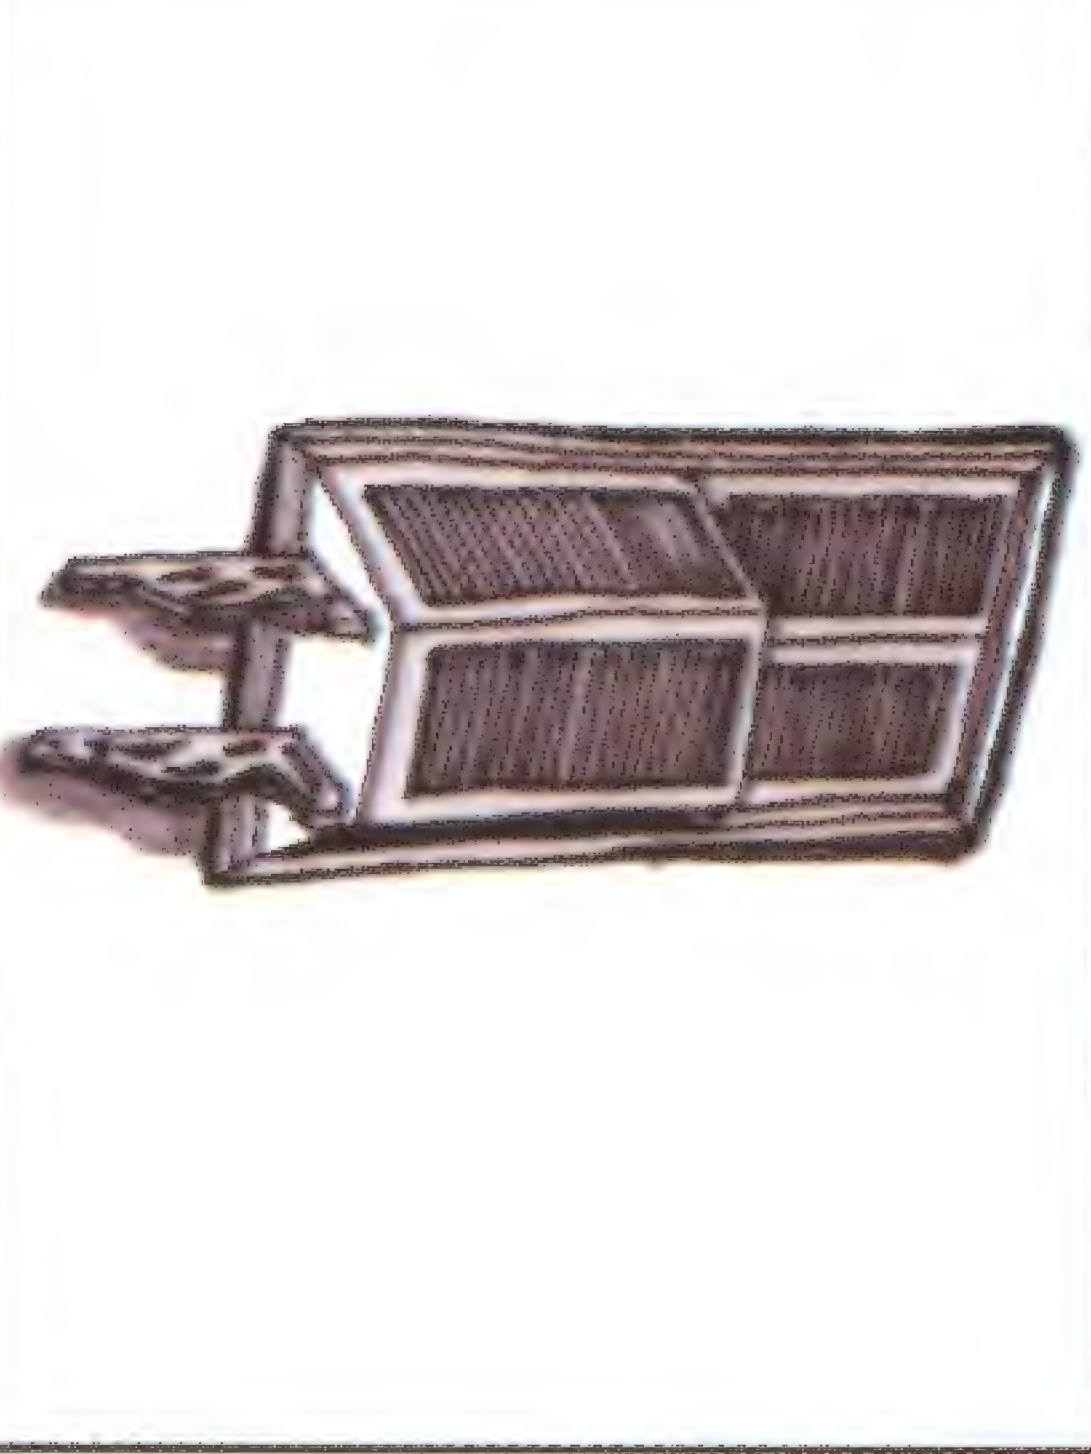
<p>Foundation date: Around 1870.</p> <p>Brief description: Basically two houses around a court, an annex for service and servants. Each house has a separate staircase. The mezza-nine floor for cooking, Storage and Services. The main floor shown here has a large central sala with rooms around it.</p> <p>The connecting door between the two houses indicate that the families were related or may be one for women, and the other for men.</p> <p>Apartment area: 80–150 m².</p>

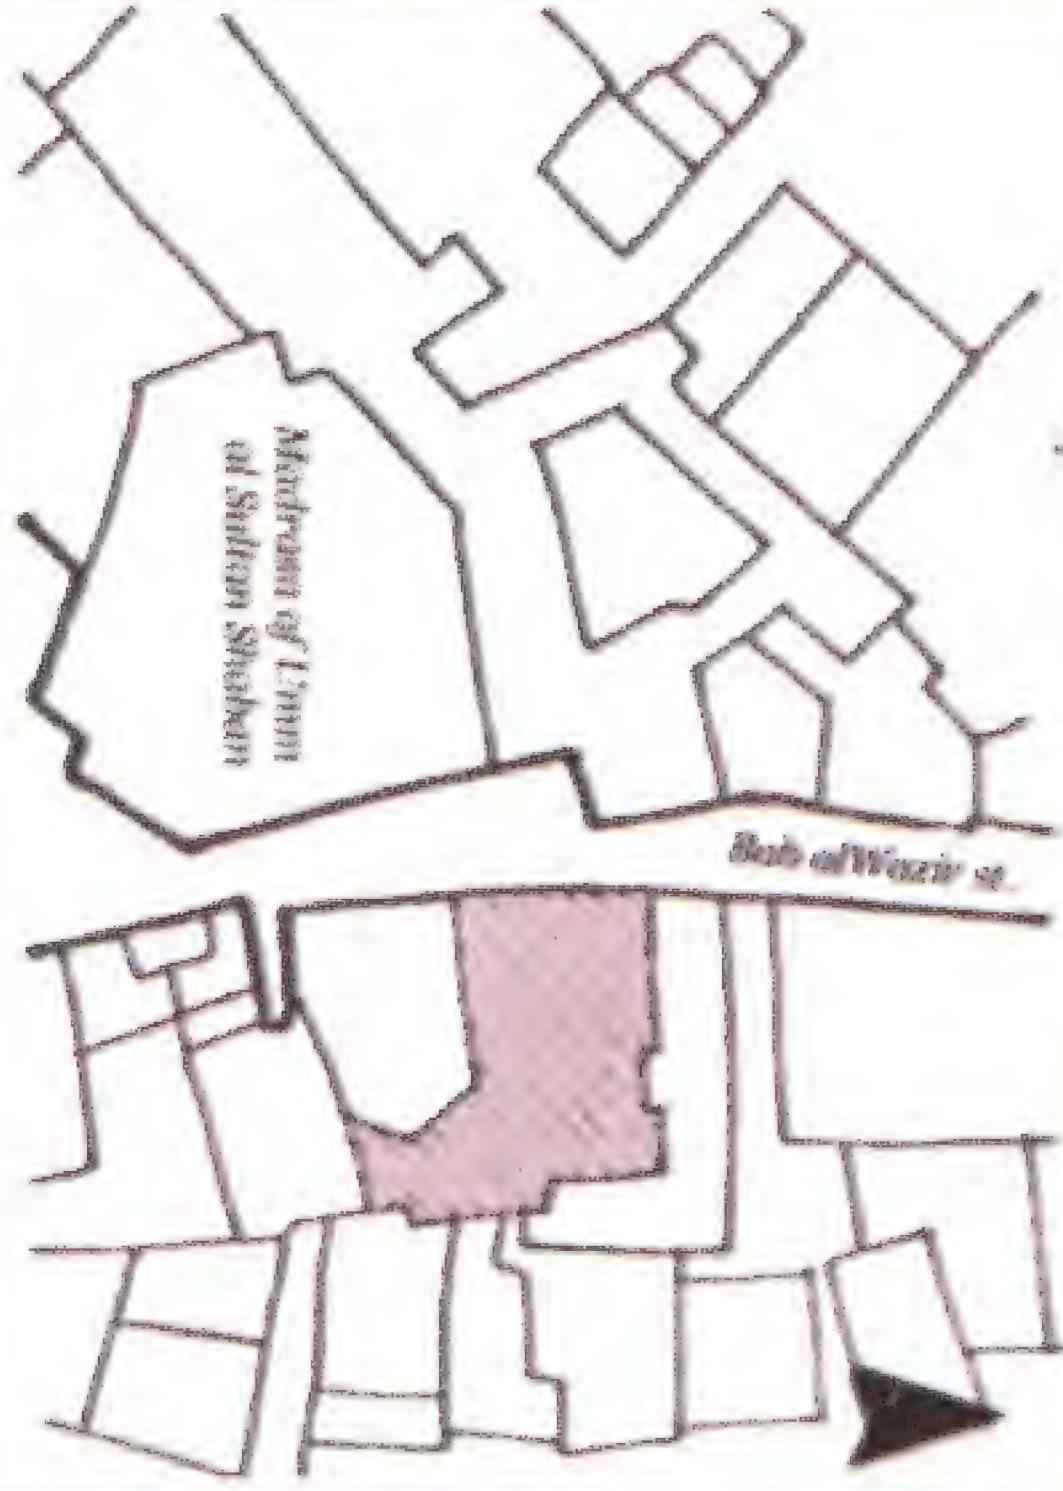
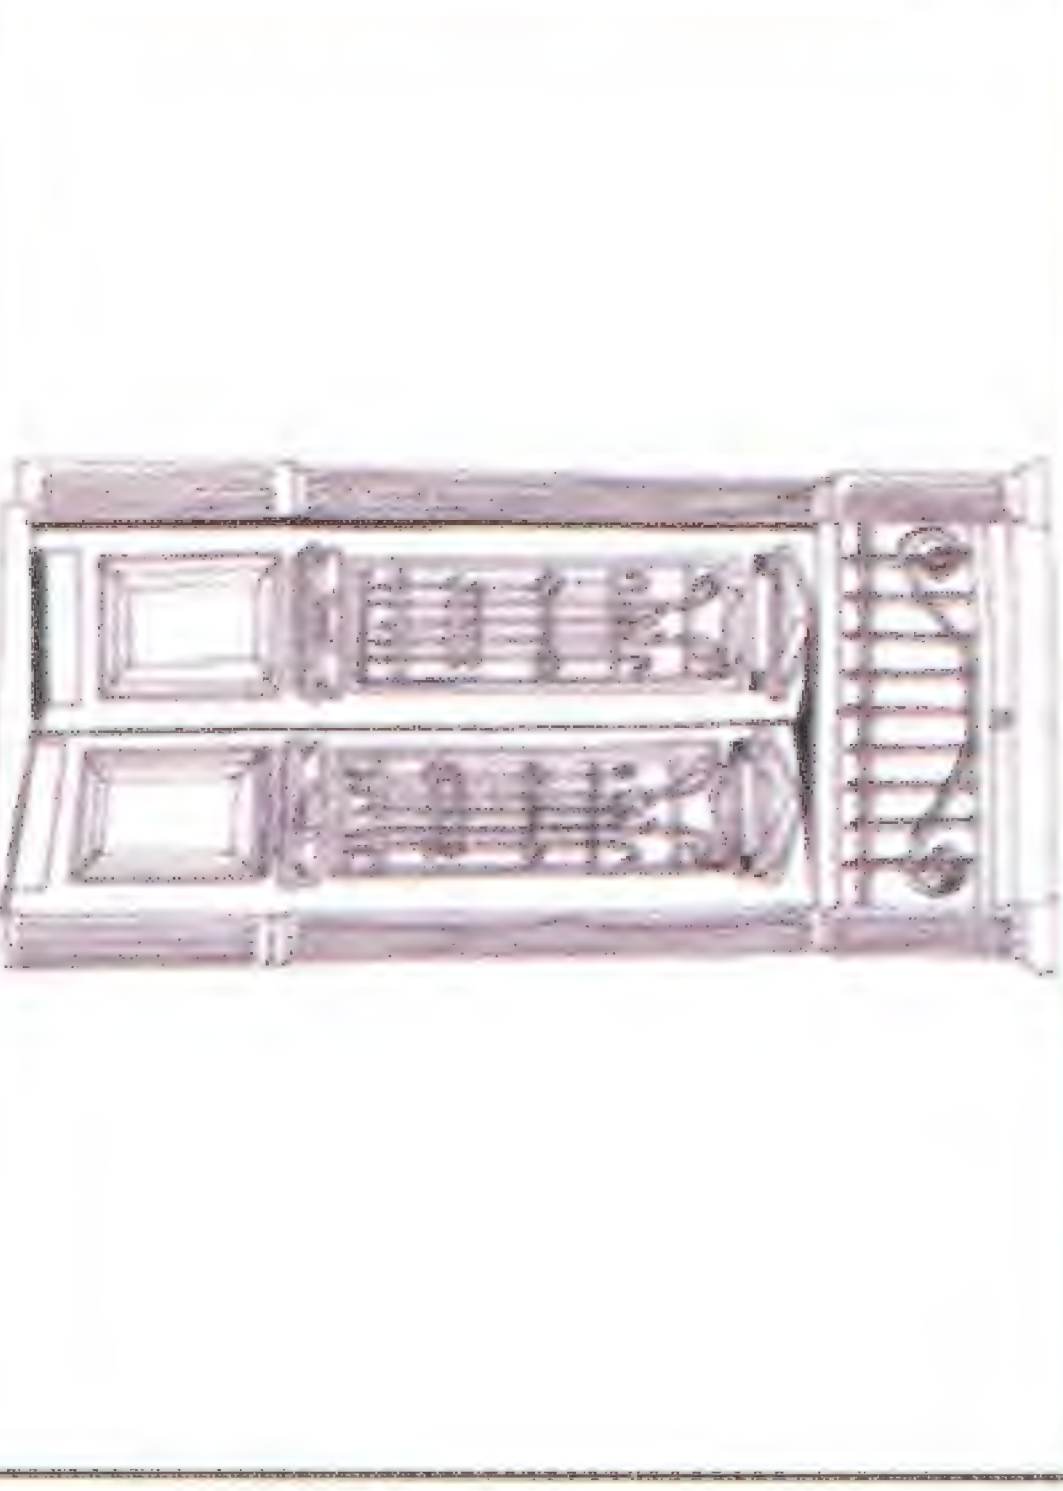
<p>Foundation date: 1850.</p> <p>Brief description: The upper floors above the ground were added later and removed after the 1992 earthquake.</p> <p>The ground floor has four shops opening on Bab al-Wazir St. A separate apartment opens on the (6,00 x 6,00) m court.</p> <p>The main floor has four apartments with open court and two light shafts.</p> <p>Apartment area: 50–150 m².</p>

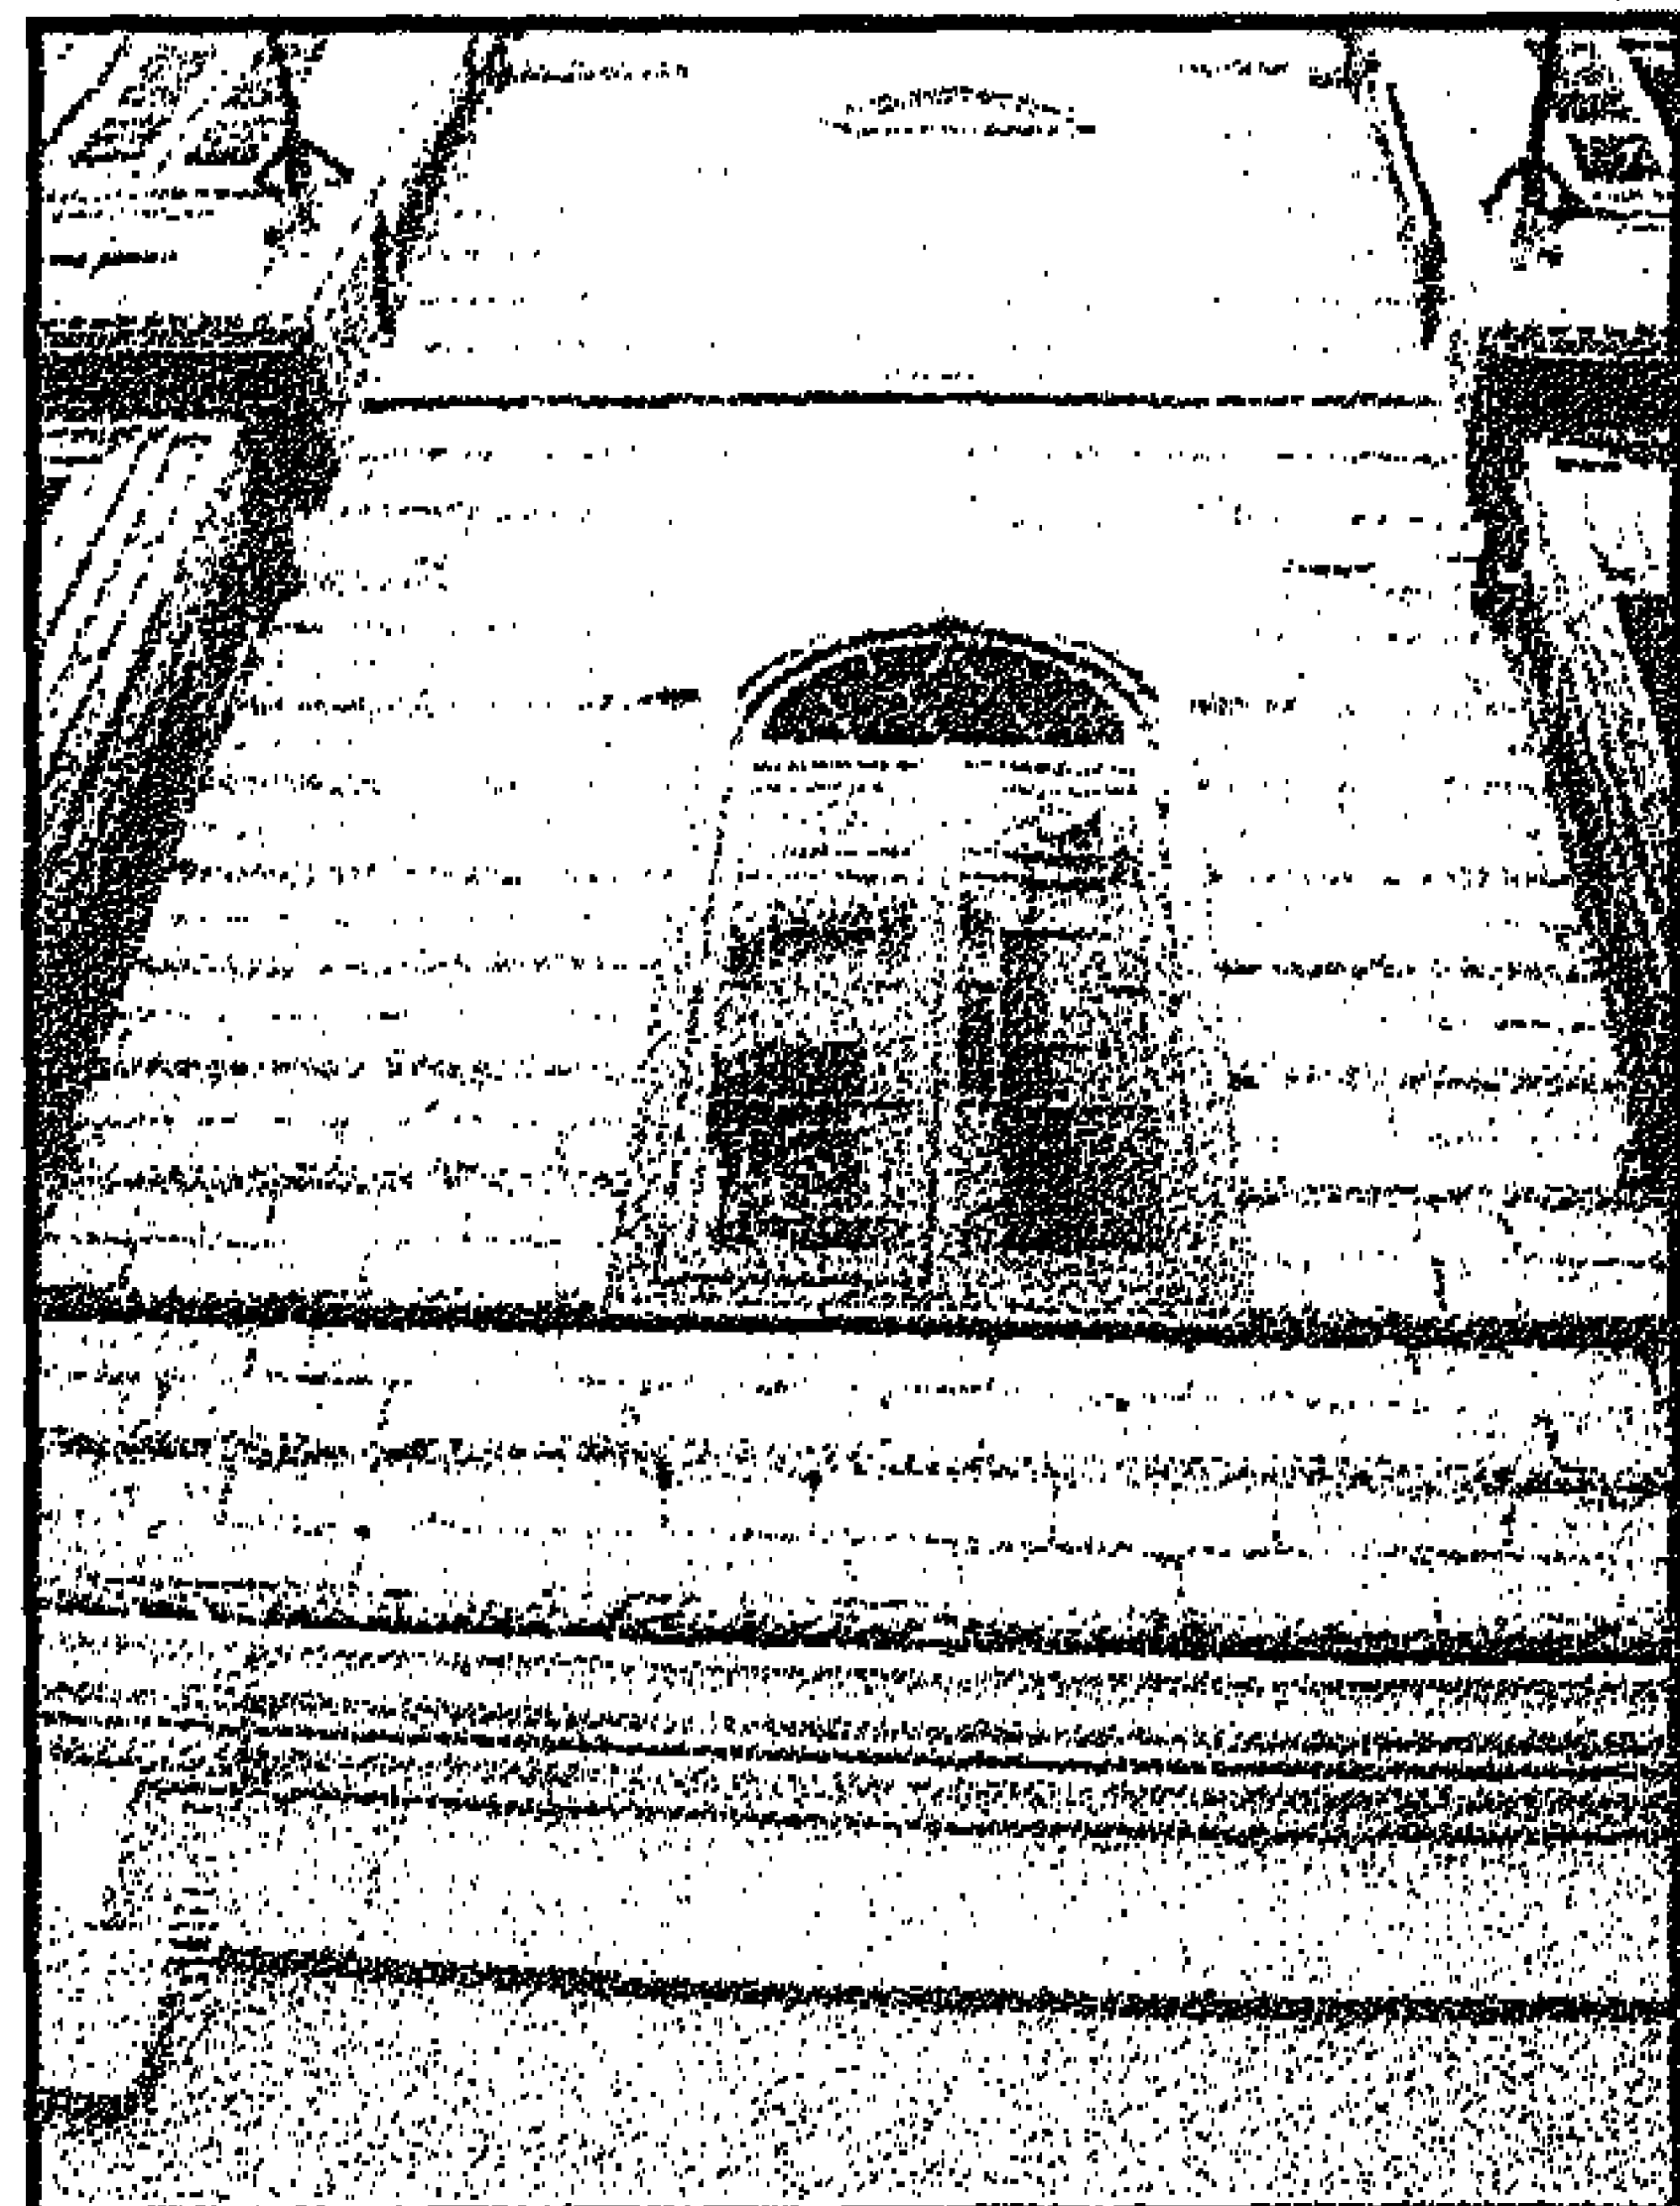
Figure 5-22 Stone façade in Bayt Abu al-Hasan after cleaning (September 2005)
